Significant conveyor uptime increase in a copper mine

SKF Three-barrier solution

A copper mine achieves major uptime success with contamination-resistant SKF Three-barrier solutions in the conveyor pulleys.

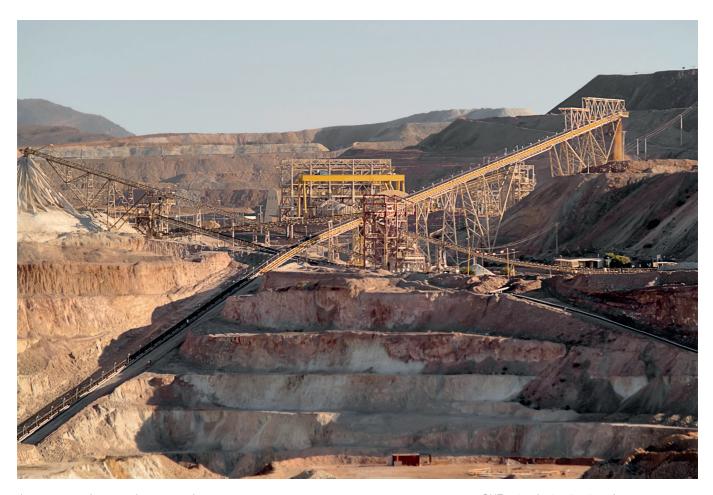
To minimize downtime and production losses, the mine owners wanted to extend the service life of their conveyor pulleys. All open bearings were replaced with contamination-resistant SKF Three-barrier solutions including sealed

SKF spherical roller bearings, a grease barrier in the housings and custom-machined seals for maximum protection.
